CASE STUDY

Capa Roma Movie Studio Rome, Italy

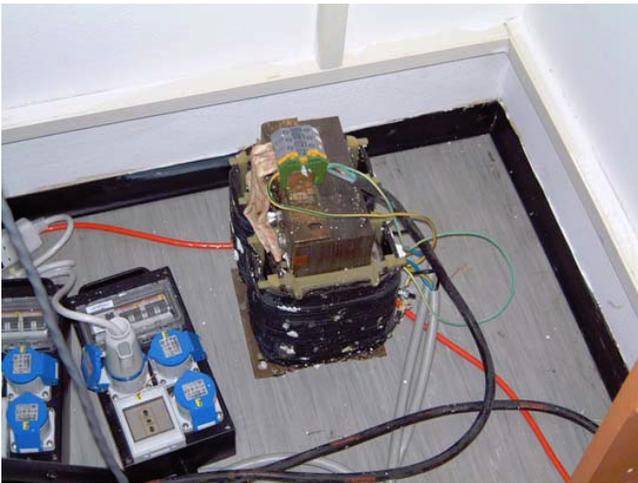
Thelma described her current problem as follows: The editing equipment, which she was using at the Capa Roma studio, had been brought over from her New York City studio. To use the equipment in Italy, a studio electrician provided a single-phase 415:240/120-volt isolation transformer to reduce the studio's higher utilization voltage down to 120-volts. The 120/240-volt 'center-tap' isolation transformer is shown in the photograph.

PQI received the call and we were on our way to Rome the same day. Fifteen hours later we arrived at the Capa Roma studio. A few simple measurements revealed a serious voltage distortion problem at the loads. THD_v levels exceeded 12%, more than twice the limits recommended by IEEE Std 519-1992. Calculations confirmed that at these distortion levels, the switch-mode power supplies' DC current would increase to 129%. The I²R 'penalty losses', resulting from this increase, would cause the power supplies to fail. Investigating further, we discovered that all of this sensitive electronic equipment was being supplied from one side of the center-tapped secondary winding. Since harmonic voltage and the resulting voltage distortion are caused by harmonic source impedance ($E_h = I_h \times Z_h$), reconnecting half the load to the other side of the center-tapped winding would effectively reduce source impedance by 50%.

Upon reconnection, THD_v levels were reduced to 6% and the power supplies cooled down immediately, as expected. Even though 6% THD_v is not ideal, it was low enough to eliminate power supply failures.
