CASE STUDY

Wynn Hotel & Casino Macau, China

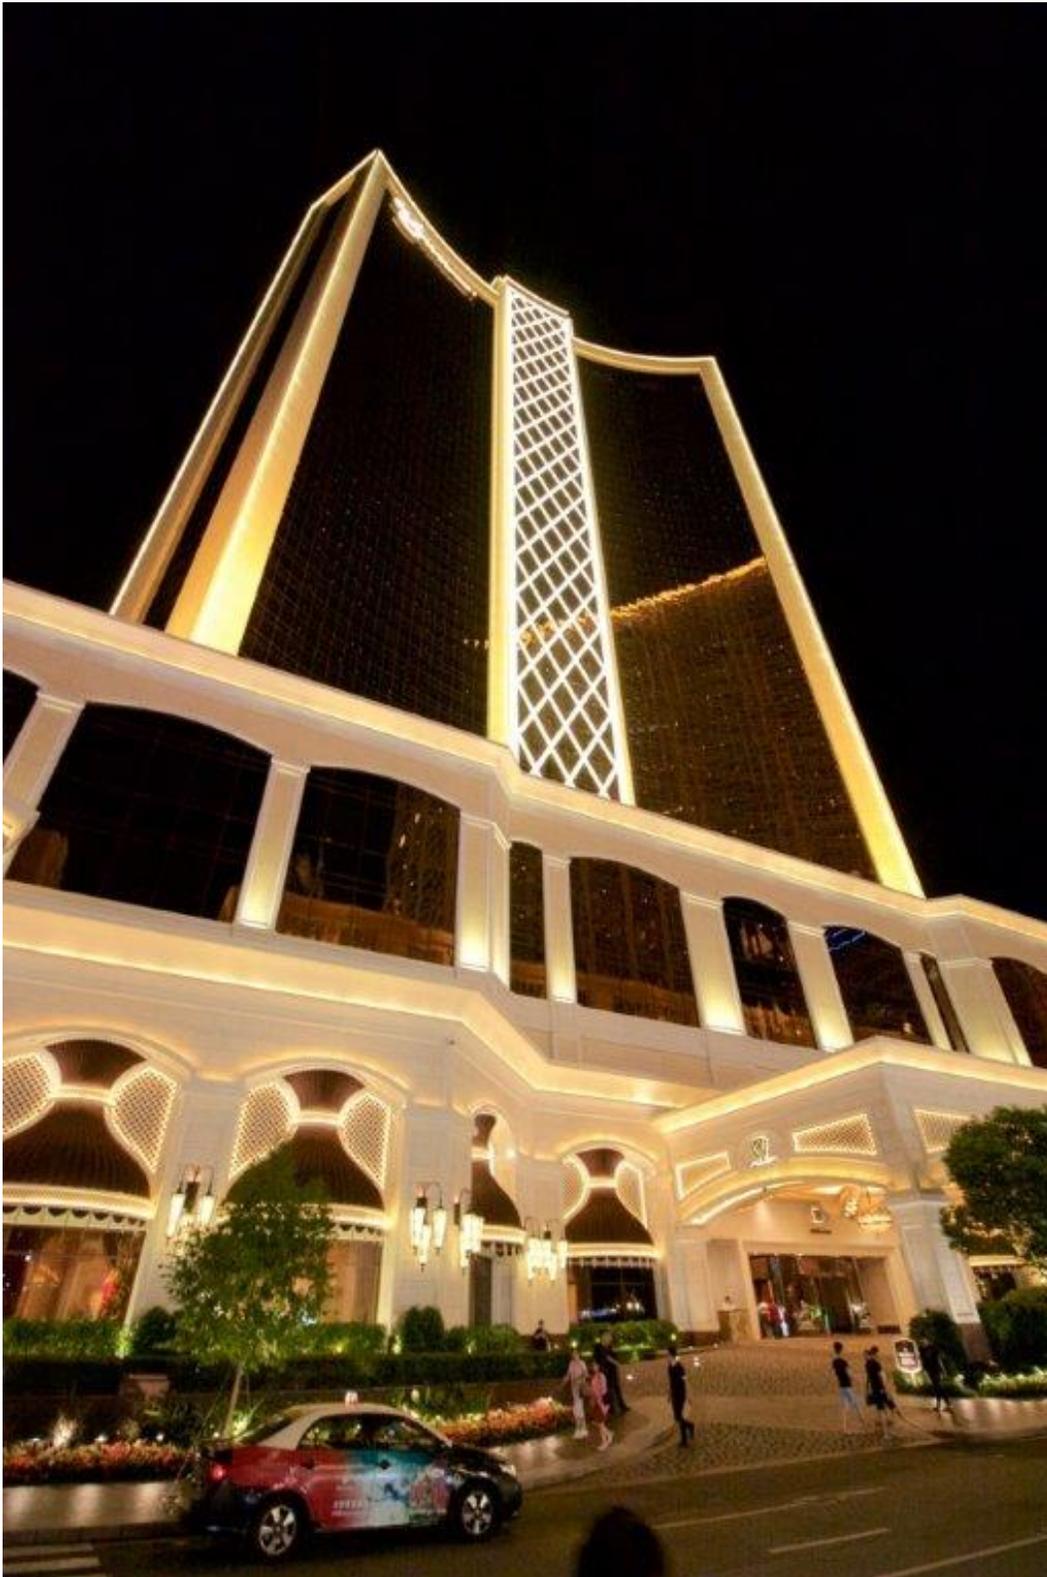
A Time-Lapse Photograph of the Encore Tower's Diamond Feature

The Diamond Feature includes approximately 70,000 randomly controlled, dimmable cold cathode fluorescent lamps. Seen at night, the lamps appear as twinkling stars. A time-lapse exposure of the display shows all lamps illuminated.

On January 15, 2010, PQI received a report regarding a severe harmonic problem at the Wynn Macau Encore tower from JBA Consulting Engineers, who had been retained to evaluate performance issues on the hotel's electrical distribution systems. During the initial commissioning, JBA observed flickering lights in the guest rooms and unusual humming and vibration in the six distribution panels that supply the hotel's Diamond Feature. The Diamond Feature is a unique lighting display located on the exterior concave facade of the Encore Tower. This display extends from the seventh floor to the fiftieth floor. The feature includes approximately 70,000 randomly controlled, dimmable cold cathode fluorescent lamps. A time-laps exposure of the lighting display may be seen in the Encore Tower photograph on page 3.
